LONG TERM CHANGE AND DOCUMENTATION BY PHOTOGRAMMETRY FOR THE PRESERVATION OF EARTHEN ARCHAEOLOGICAL SITE

Yukiyasu FUJII ¹⁾ and Kunio WATANABE ²⁾

ABSTRACT

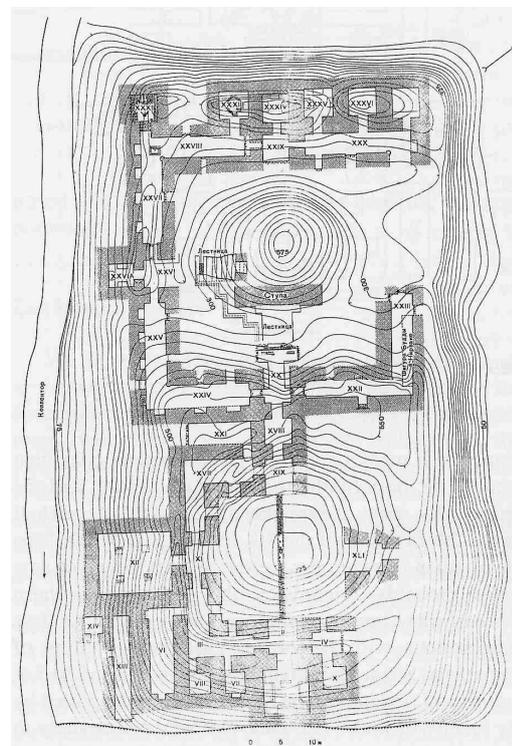
Fig. 2 Topographic map and plan of the building, Ajina Tapa excavated by the Moscow Institute of Oriental Studies (Litvinskij and Zejmal, 2004)

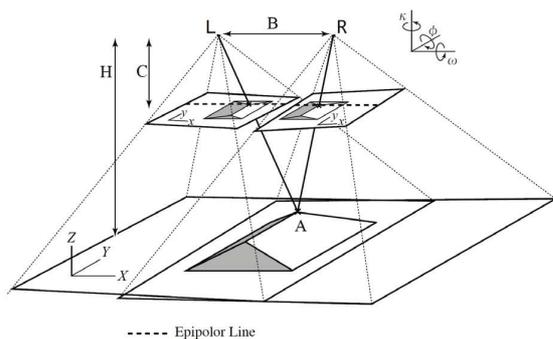
Fig. 3 Overlapping pairs of stereo-photographs and a target object

L: left camera. R: right camera. x, y : 2-D coordinate on the photographs. X, Y, Z : 3-D coordinate for the camera positions and the target objects. ω, ϕ, κ : orientation parameters for the left and right cameras H : the distance from the cameras to the object. B : the distance between two cameras. C : focal length of the camera (lens). A : an arbitrary point on the object. The plane defined by the three points, L, R , and A is an epipolar plane. The two lines where this plane intersects the two photographs are refer to as epipolar lines (break lines).

Photogrammetry is the process of deriving metric information about an object through measurement on photographs of the object (Mikhail et al., 2001). Obviously, two-dimensional co-ordinate can be gained from a single photo (two-dimensional plane). If we have two photos of the same object from different directions, we can get three-dimensional co-ordinates of the object (Fig. 3).

A three-dimensional (3-D) morphology can be produced from a pair of overlapping stereo-images. The information of camera positions and orientations ($X, Y, Z, \omega, \phi, \kappa$ for left and right cameras) are needed to get the three-dimensional co-ordinates of the target object (Fig. 3). However, it is difficult to get the accurate positions and directions at the same time when taking a pair of photographs. Control points, of which the 3-D co-

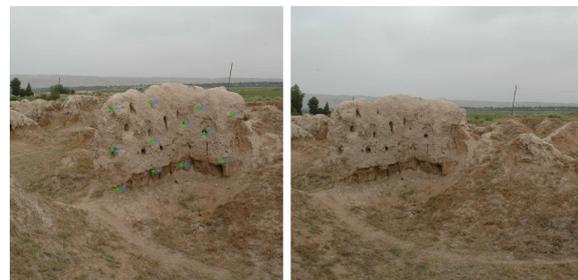
Fig. 4 A pair of stereo-photographs of a damaged wall (Wall A). Crossed circles on the left photograph show control points

ordinates are measured in advance, are included in the photograph (Fig. 4). Total Station was applied to measure the control points. The Total Station (TS) is an optical measurement for surveying that is formed by an electronic theodolite, an electronic distance measuring tool and an external computer. The camera positions and directions can be inversely calculated from the control points by means of least-square adjustments (LSA) with 3-D digital photogrammetric software. At least five control points, which might be spread over the object wall, can be needed for the calculation of the camera positions and directions. After the LSA in the stereo-photogrammetric program, the residuals can be calculated for each pair of stereo-photographs.

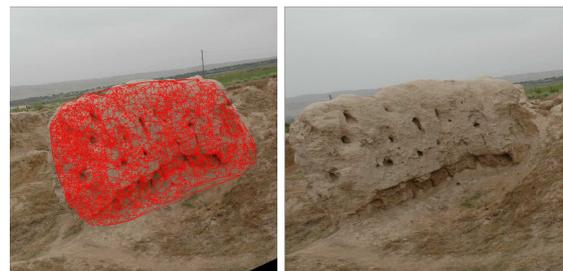
Fig. 5 Triangle Irregular Network (TIN) on a stereo-pair of photographs, Wall A

After the calculation of camera positions, the software can give matching of the same positions on epipolar lines over a pair of digital images by means of the difference of color and contrast, and generates 3-D coordinates of the points. The epipolar lines are two lines where epipolar plane intersects a pair of overlapping photographs. The epipolar plane is known as the plane defined by the three points L, R , and A (Fig. 3). The 3-D data of about 3,000 points were generated on the photographs. Those points are connected with lines and the surface morphology of the wall is constructed as a Triangle Irregular Network (Fig. 5). The great advantage of digital photogrammetry is to connect the photo images to a Digital Terrain Model (DTM). The result is a texture mapping model, which can be viewed from multiple directions.

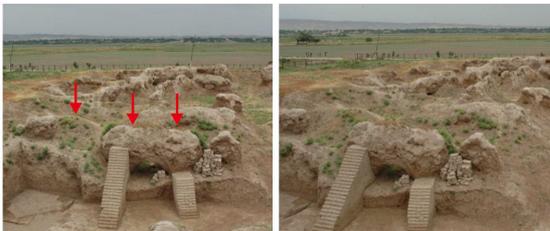
Fig. 6 A pair of stereo-photographs taken from the top of Stupa. Arrows show hidden areas by walls.

Therefore 14 pairs of stereo-photographs were taken in the site of Ajina Tapa. These photographs almost cover the total area of Ajina Tapa. However, some areas in the photographs were hidden by high monument walls. For example, in a pair of overlapping photographs, which was taken from the top of the Stupa, some areas are hidden by the monument walls (arrows in Fig. 6). 3-D information cannot be gained in such areas.

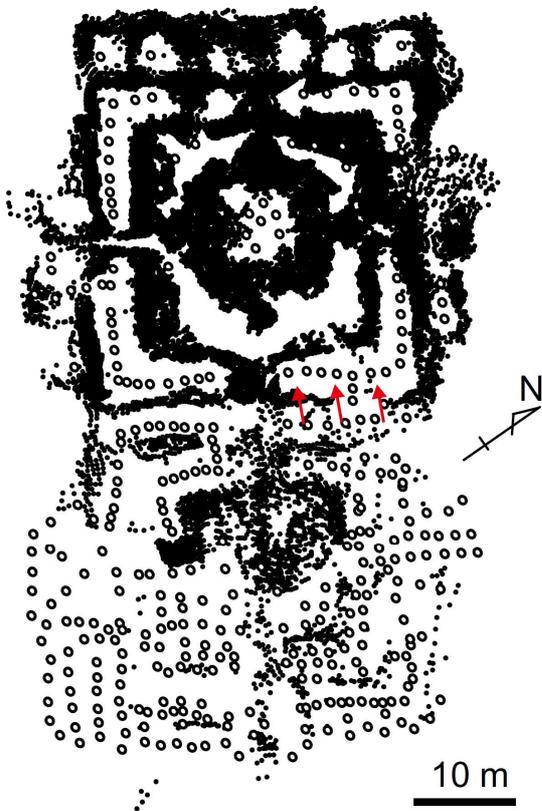
Fig. 7 3-D points gained from photogrammetry (black circles) and TS (white circles).

Black circles in Fig. 7 show 3-D points which were gained from 14 pairs of stereo-photographs. Some blank areas show hidden areas in the photographs such as Fig. 6 (arrows). Direct measurements were applied for the hidden areas with TS. Newly gained 3-D points (white circles in Figure 7) were added into the photogrammetric data.

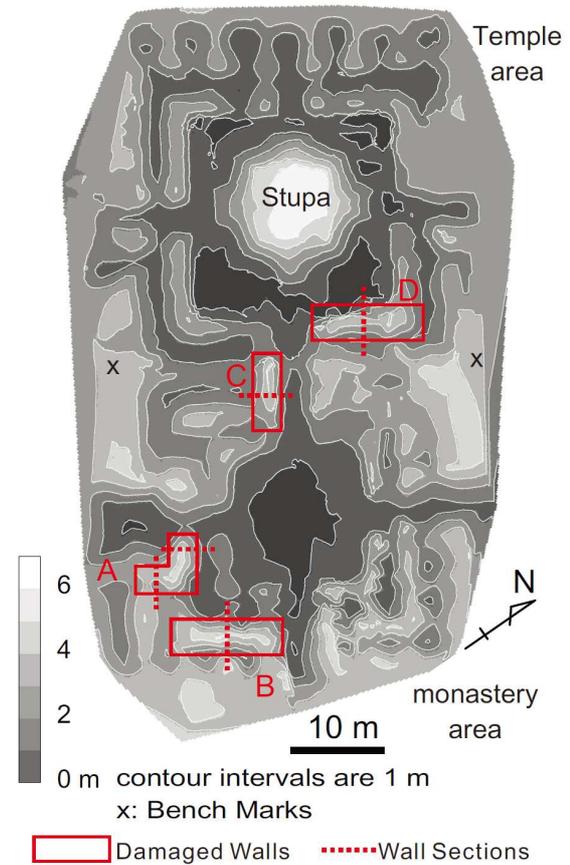
Fig. 8 Total map of Ajina Tapa. The site is composed of two parts, northwestern temple (stupa) area and southeastern monastery area.

The points gained from both photogrammetry and direct measurement has been used to make topographic map of the site. Fig. 8 shows the total map of the site. It is a Digital Elevation Model (DEM) with elevation encoded by intensity values, with brighter values being higher, and overlaid by 1 meter contour lines.

Four damaged walls (Fig. 9) were mapped in 3-D with digital photogrammetry. Apart from Wall A, two pairs of photographs were taken of each wall to make DTMs of both the sides. Wall A (Fig. 8) is a reversed L-shape in ground plan, so pairs of photographs of the northeast and southeast sides were taken from the northeast and southeast respectively. Another pair of photographs of the L-

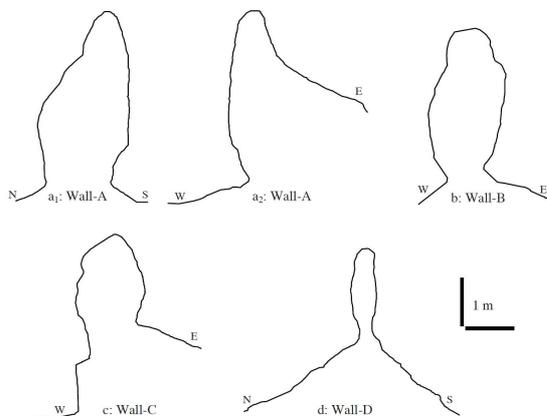
Fig. 9 Sections of the damaged walls. See Fig. 8 for locations of the walls.

shaped wall was taken from the southwest (Fig. 4). The control points for each pair of stereo-photographs were given 3-D co-ordinate defined by the benchmarks (Fig. 8). In this way the original position of each DTM was established and complete cross-sections of each wall were obtained (Fig. 9). The massive wall had been constructed with pakhsa blocks or mud bricks on pakhsa base, and the original shape of the section may have been rectangular. The original thickness of the wall was 2.4 m, which was recorded by Litvinskij and Zejmal (2004). The original height of the wall is not clear for Wall A, but the walls of the monastery area had an average height of 2.5 m with a maximum height of 5 m (Litvinskij and Zejmal, 2004). The maximum width of the remaining wall is about 2 m (Fig. 9). The current shape of the wall is very different from the original rectangle because of erosion. First, the upper part of the wall was strongly eroded and has become rounded. Both sides (north and south) are eroded deeply, a little more prominently on the north side than on the south. Second, the basal part of the wall was undermined to make shallow coves and was eroded asymmetrically. Its south side was more deeply eroded than north side. Some measured sections of damaged walls are shown in Fig. 9a–d. Fig. 9b shows an east–west section of Wall B, which is situated at the southern monastery area and oriented in a north–south direction (Fig. 8). The upper part of the wall is eroded and the top is rounded. Both east and west sides are equally eroded. The maximum width is now about 1.5 m, which is considerably thinner than the original thickness of 2.4 m. The basal part is more deeply eroded than the middle part of the wall. Other damaged walls show more or less similar features, irrespective of their positions and orientations. Common characteristics of the erosion are as follows:

1. The walls are significantly eroded compared with the original outlines.
2. The top of the walls are eroded and rounded.
3. The basal part is more undermined and thinner than middle part of the walls.

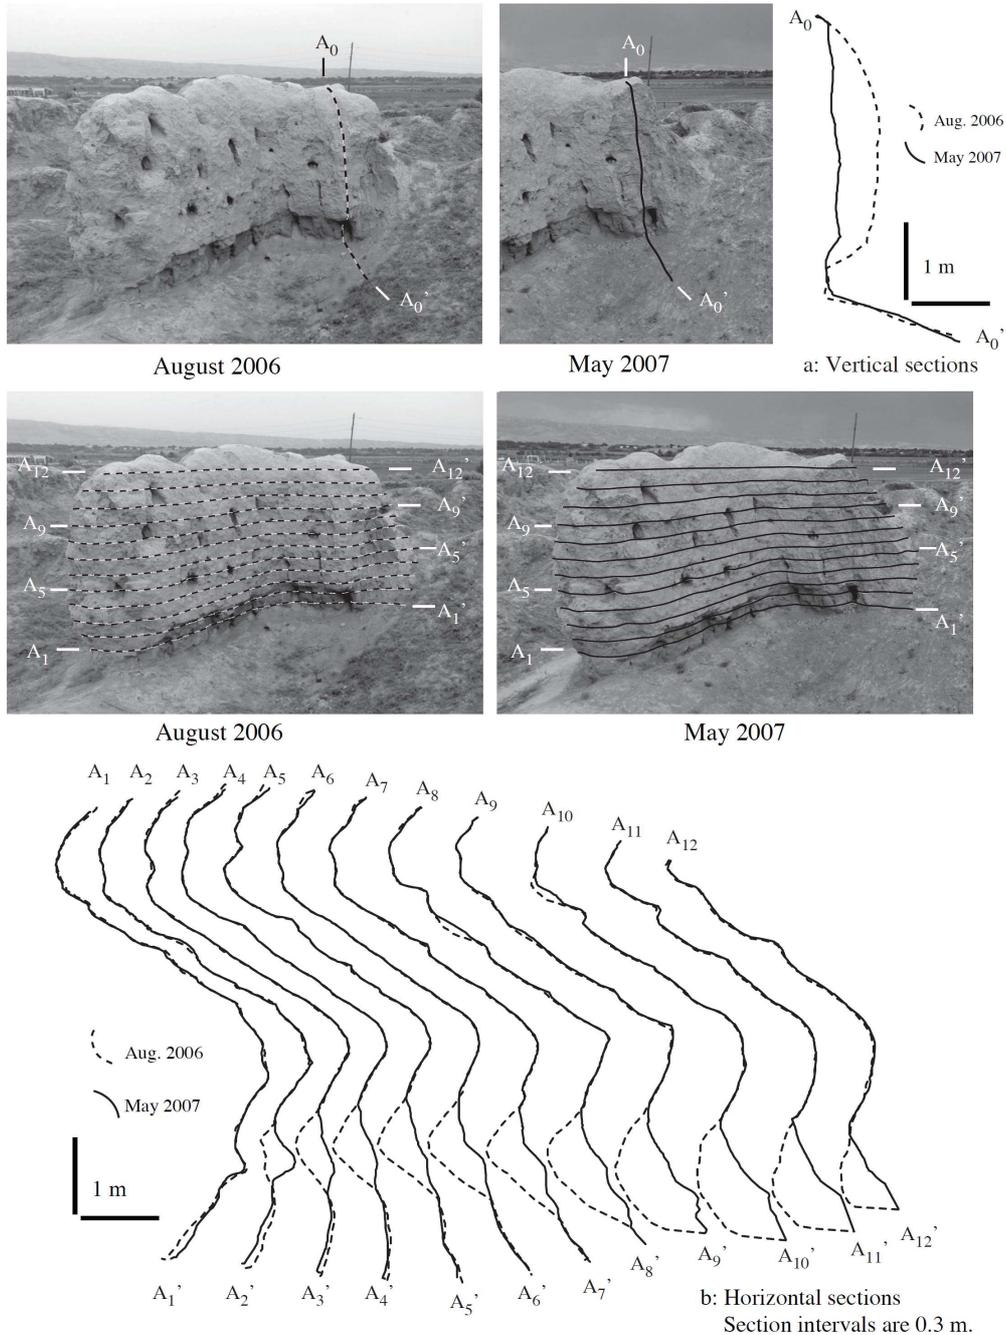
Fig. 10 Change of Wall A (L-shaped segment). Upper row: views from southwest, left in 2006, right in 2007. a: Vertical profiles. Middle row: photos showing reference horizontal sections, left in 2006, right in 2007. Lower row: ground plans of the reference horizontal sections. Southern rim collapsed between August 2006 and May 2007 (Fujii et al., 2009).

Rapid erosion can be seen at the south-eastern end of Wall A, with the basal part being severely eroded when it was measured in August, 2006 (broken lines in Fig. 10). The height of the wall was then about 4 m, but the basal part about 0.5 m to 0.8 m above the ground surface was deeply undermined. The maximum depth of the erosion was about 0.6 m and looks like a notch. About nine months later, the top and middle parts of the wall had collapsed and the surface of the wall had become simple plane by May 2007 (solid lines in Fig. 10). The volume of the collapsed part is about 1.6 m³, which is calculated from a series of sections made by photogrammetric measurements. The sections measured in 2006 and 2007 are made from DTMs which were calculated from the same 10 control points. Therefore, the sections are almost identical except for the collapsed or eroded parts (Fig.10). These data obtained by digital photogrammetry provide the quantitative basis for evaluating the advance of the erosion of the wall. In this way, the progress of the deterioration of the walls of Ajina Tapa was recorded.

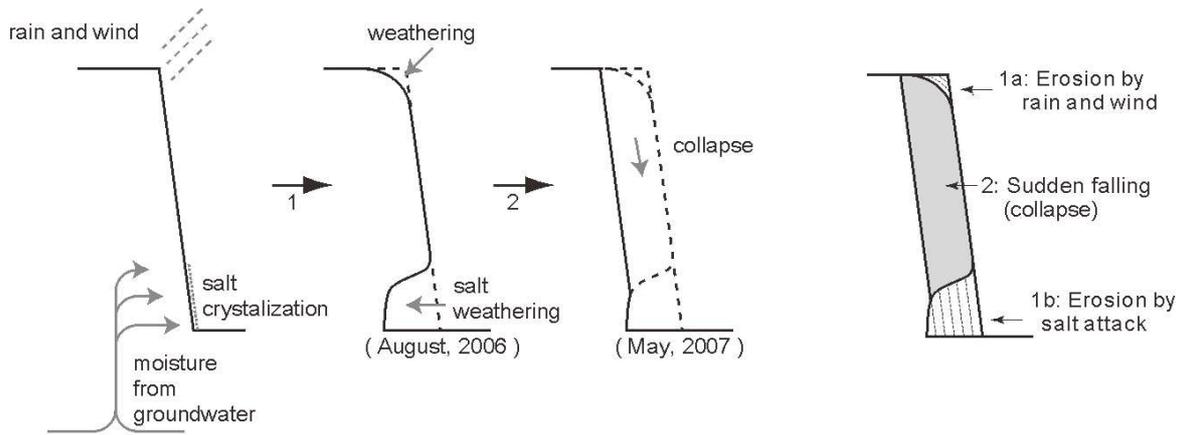
Fig. 11 Schematic erosional process of the wall. 1: Soluble salt is transported with capillary groundwater, and crystallized on the surface of the wall. Salt crystallization attacks and erodes the basal part of the wall. The top part of the wall is also eroded by rain and wind. 2: The upper wall, which lost support due to the thinning of the basal part, collapses suddenly. The wall surface becomes planar, and the erosion will continue to decay the wall. (Modified from Fujii et al., 2009)

Prior to the original excavations, the site was totally covered with sediments and appeared as a mound (Litvinskij and Zejmal, 2004). After the excavations, there was no appropriate preservation or protection work carried out on the buildings. Therefore, the building walls have been exposed since 1975. The erosion rates are relatively slow for mud brick and medium for pakhsa and the wetting and drying test shows very little failure for both materials (Fodde et al., 2008a). Therefore, it appears that rain or wind have been main erosive agents for the tops of the walls for about 30 years. Winter is the rainy season in the area of Ajina Tapa, so the walls are more strongly eroded by rain water in such season. The building wall was badly eroded, resulting in the rounding of the top of the building walls (Fig. 11).

can readily seep on to the floor and evaporate in the summer sun. The salts cause damage to the wall (Goudie and Viles, 1997) and the combination of wind and windblown silt adds strength to the forces of erosion. With annual repetitions of the process, the basal part of the walls became thinner than the middle part (Fig. 11-1).

Due to the thinning of the basal part of the walls by salt attack, the upper sections lost support from the base. Eventually, the undermined part of the wall collapsed under its own weight (Fig. 11-2). The collapse is caused by structural weakness, particularly in the rainy winter season, when the earthen materials contain more moisture and have less strength. In addition, earthquake and other external forces may have precipitated a sudden failure in the wall. The wall becomes thinner and the surface is planar after a collapse event, but the decay continues under the effects of soluble salt attack, rain, and wind (Fig. 11).

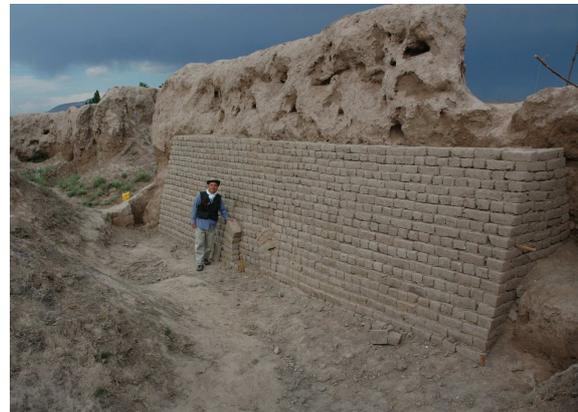
Fig. 12 An example of conservation work. Wall B is supported by buttresses made of new mud bricks. New mud bricks would be covered by new mud plaster as Fig. 13.

Some conservation works have been carried out on this project (Fodde et al., 2007) to the extent that some unstable walls have been supported by buttresses made of new mud brick and plaster (Fig. 12). The walls are designed not to be vertical and the bottom is thicker than the top. This is both to prevent the failure or collapse of the walls and to reduce the decay caused by salt weathering. Wall A had been also repaired with new mud brick and plaster. In addition post-repaired structure has been also documented by photogrammetry. Fig. 13 shows sections both before and after the conservation work. Historical damaged wall had been fully covered by new mud brick and new plaster. It can be shown in Fig. 13 on the results of photogrammetric monitoring.

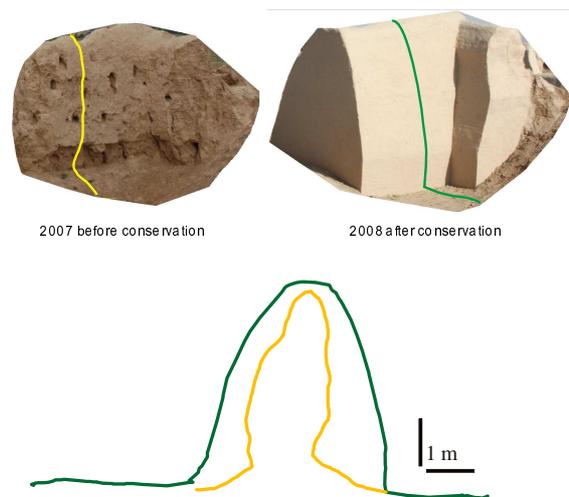
Fig. 13 Texture mappings and sections of Wall A, pre- and post-conservation work. Upper left shows a pre-conservation texture mapping, upper right shows a post-conservation one. Lower shows their sections.
